TITLE: Occurrence of Corrosion in Airframes

TITLE: Aging Aircraft Fleets: Structural and  
Other Subsystem Aspects [le Vieillissement des  
flottes d'avions militaires : aspects structures  
et autres sous-systemes]

# Occurrence of Corrosion in Airframes

**M. Colavita**

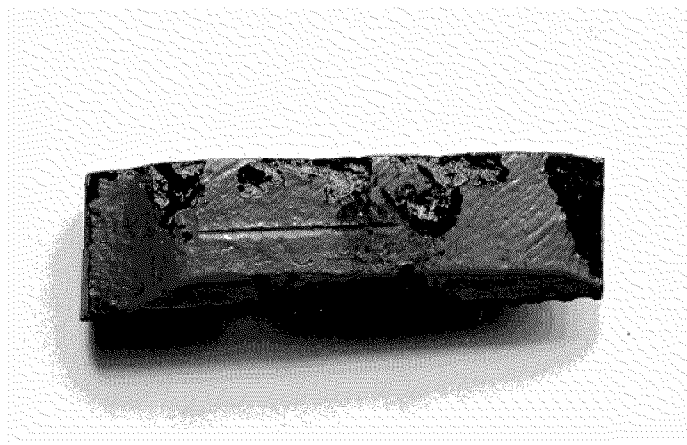
**Fig. 7 – Pitting Corrosion on MB-326 Balance Tabs**

Here following (Fig. 6 and 7) some cases occurred in the recent past are shown.

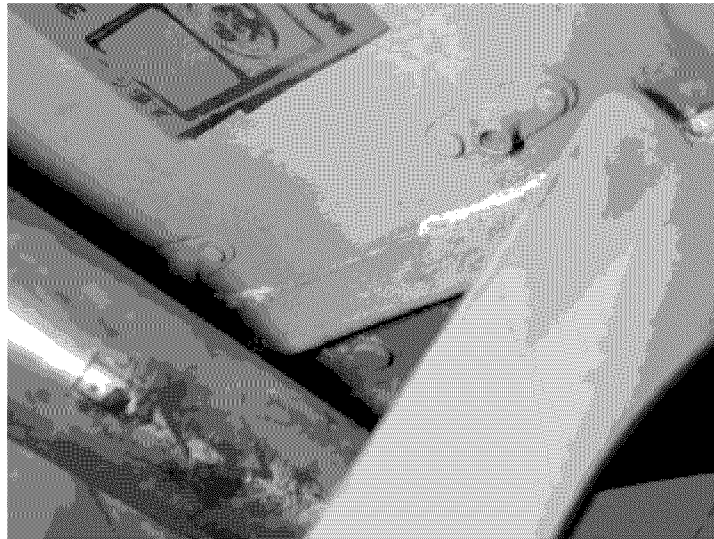
**Fig. 11 – Galvanic Corrosion on the MB-339 Attach Fitting**

Looking at the galvanic series it's easy to realize that magnesium alloys are very susceptible to suffer galvanic attack when used in junction with any other metal (Fig. 9-11).
